## Case Studies in Stabilization

### Introduction

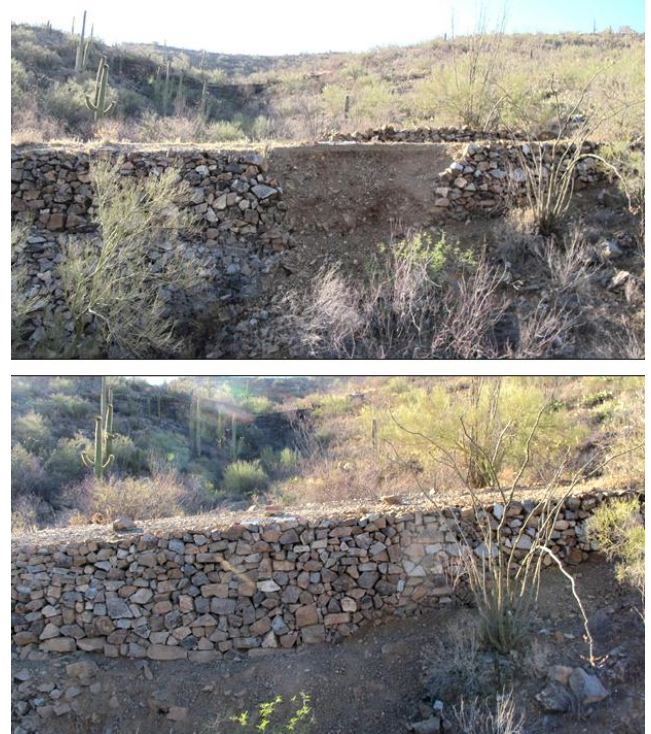
**Figure 1. Top: the collapsed portion of the stacked rock retaining wall. Bottom: same wall segment as in top photo after reconstruction.**

In 2010 portions of two stacked-rock retaining walls unexpectedly suffered catastrophic failure (collapse) due to water erosion. The collapsed portion of walls left the remaining intact portions susceptible to further erosion and possible total collapse. The collapsed wall segments also threatened the stability of the public trail (Figure 1).

A grip hoist was used to move and position the very largest rocks, some of which measured up to 3 feet by 1 foot in size. All of the rock used to reconstruct the wall segments was found at the base of the collapsed wall. No mortar was used. The rocks used to repair the walls were stacked and battered to match the adjoining original wall segments. Fill, in the form of crushed rock, also found at

the base of the collapsed wall, was used to fill in behind the reconstructed walls (Figure 2). The work area was

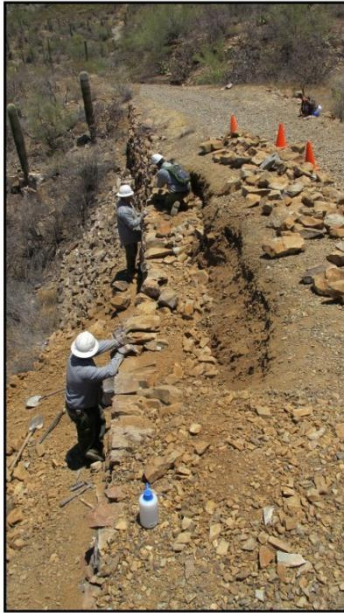
**Figure 2. Stabilization crew working on retaining wall along King Canyon Road.**

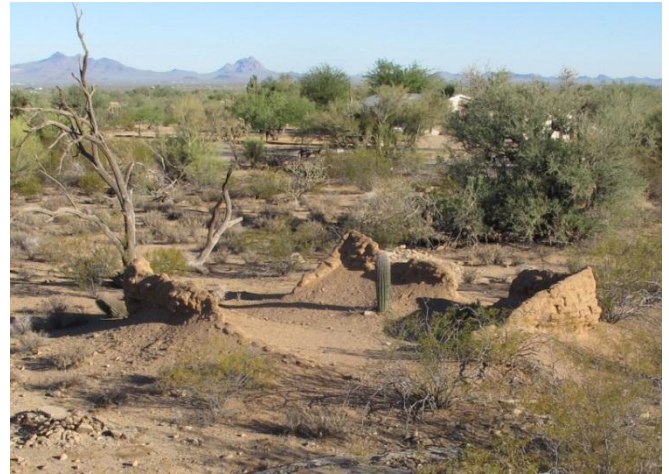
**Camp Pima.** Camp Pima is a Civilian Conservation Corps camp that operated from 1933 to 1941. Several of the buildings were constructed of adobe brick and mortar. Little is left of the adobe-walled buildings; eighty-plus years of weathering and probably some vandalism have taken its toll (Figure 3). Only three buildings still have standing wall segments.

**Figure 3. The remains of an historic adobe-walled structure at Camp Pima.**

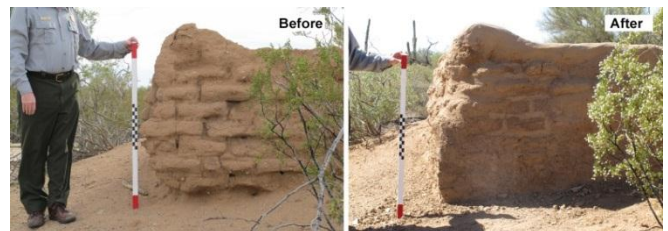
**Figure 4. The remains of an historic adobe-walled structure at Camp Pima. Left: Photograph of the NE corner showing basal erosion and loss of original mortar. Right: The same corner as in the photograph at left after stabilization. Mortar joints have been repointed and material has been added to the base to create a solid foundation.**

In 2014 a stabilization crew from Tumacacori National Historical Park was brought to the park to conduct the first stabilization effort under the cyclic maintenance program. The project at Camp Pima included the repointing of mortar joints, filling voids between adobe bricks and filling basal erosion to create a stable foundation for the wall (Figure 4). A sacrificial layer or cap of adobe was also applied to the tops of each wall. The cap will help reduce erosion along the top course of adobe bricks.
